ALABAMA DEPARTMENT OF TRANSPORTATION

**Subject: Annual Inspection Report
Evergreen Municipal (Middleton Field) Airport**

ANNUAL INSPECTION REPORT

EVERGREEN MUNICIPAL (MIDDLETON FIELD) AIRPORT

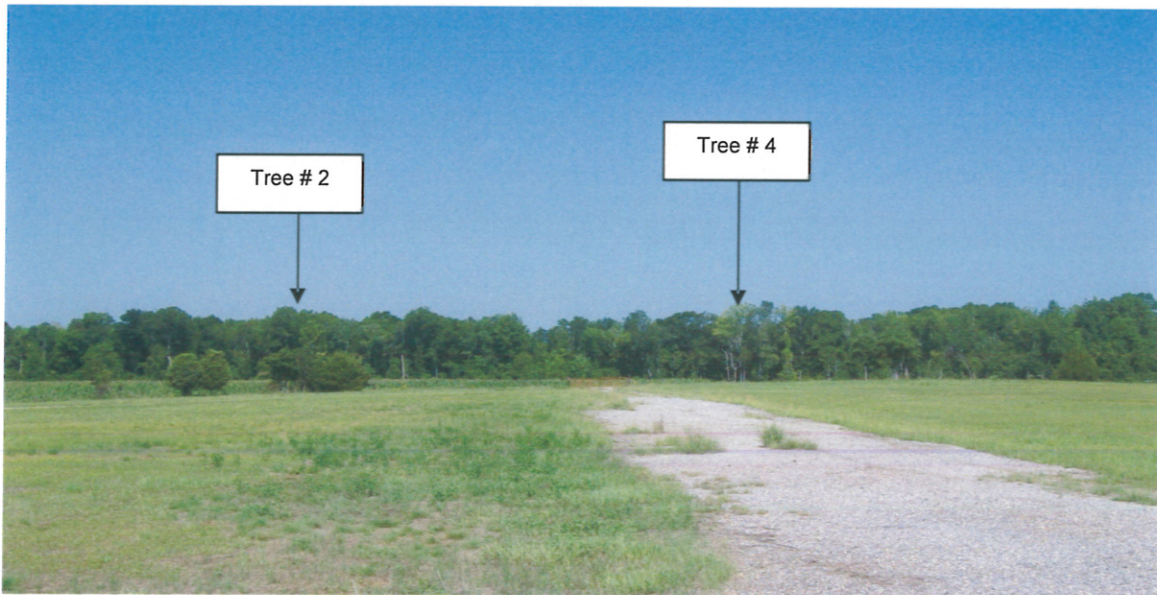
Photo # 1 – Runway 10 Approach

- Runway 10 – Tree identified as Tree # 2 obstructs the ALDOT approach/departure path and Tree # 4 obstructs the approach slope within the limits of the FAA runway protection zone (See Photo # 1 & Appendix 2).
- Runway 28 – Trees identified as Tree # 6, Tree # 7 and Tree # 8 obstruct the ALDOT approach/departure path (See Photo # 2 & Appendix 3).

- * 1. TREE - 13' ABOVE RUNWAY END
546' FROM RUNWAY END
64' RIGHT OF CENTERLINE
26:1 OBSTRUCTION CLEARANCE SLOPE
- 2. TREE - 23.5' ABOVE RUNWAY END
546' FROM RUNWAY END
29' RIGHT OF CENTERLINE
14:1 OBSTRUCTION CLEARANCE SLOPE
- * 4. TREE - 59' ABOVE RUNWAY END
1197' FROM RUNWAY END
279' LEFT OF CENTERLINE
16:1 OBSTRUCTION CLEARANCE SLOPE

- While these trees are representative of obstructions in the approach departure path of runway 19, 10 and 28 they may not be the only trees that violate the 20:1 approach/departure path, and all obstructions must be removed for an operating license to be issued.

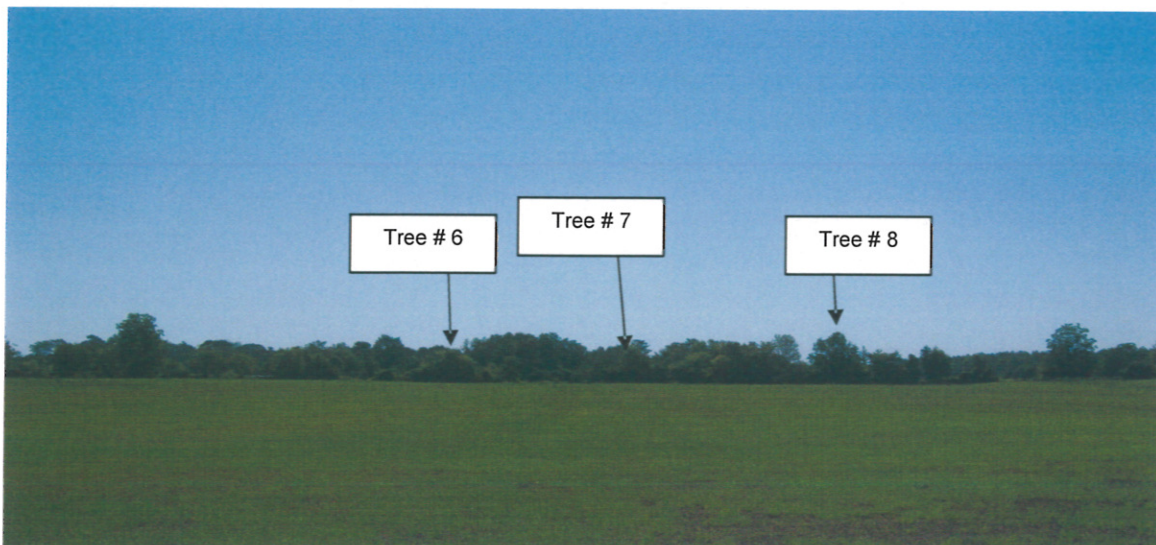
Photo # 2 – Runway 28 Approach

6. TREE - 33' ABOVE RUNWAY END
85' FROM RUNWAY END
108' RIGHT OF CENTERLINE
19:1 OBSTRUCTION CLEARANCE SLOPE
 7. TREE - 37' ABOVE RUNWAY END
879' FROM RUNWAY END
16' LEFT OF CENTERLINE
18:1 OBSTRUCTION CLEARANCE SLOPE
 8. TREE - 44' ABOVE RUNWAY END
858' FROM RUNWAY END
116' LEFT OF CENTERLINE
14:1 OBSTRUCTION CLEARANCE SLOPE
- NOTES:
1. THIS SKETCH IS PROVIDED FOR INFORMATIONAL PURPOSES ONLY AND SHOULD NOT BE USED FOR ANY OTHER PURPOSE.
 2. REFER TO THE LATEST ALP DATED APRIL 21, 2003 FOR THE FAA AIRPORT DESIGN STANDARDS.

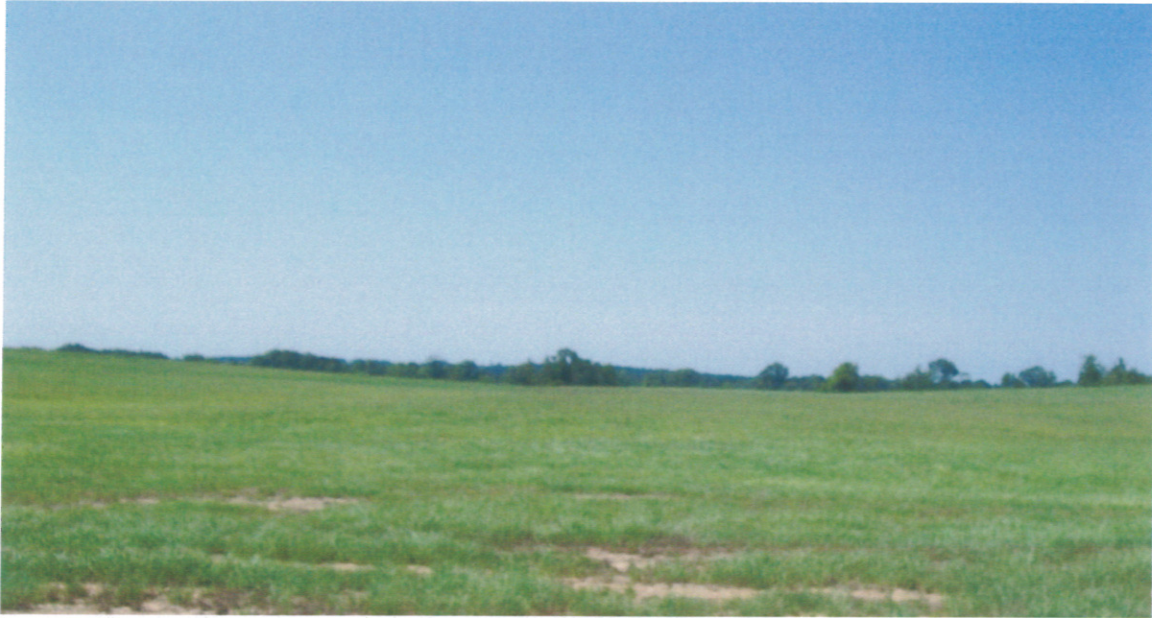
Photo # 3 – Runway 1 Approach

- Runway 1 – No obstructions (See Photo # 3).
- Runway 19 – No obstructions; however a tree identified as Tree # 10, if allowed to continue growing will eventually penetrate the ALDOT approach/departure path (See Photo # 4 & Appendix 4).

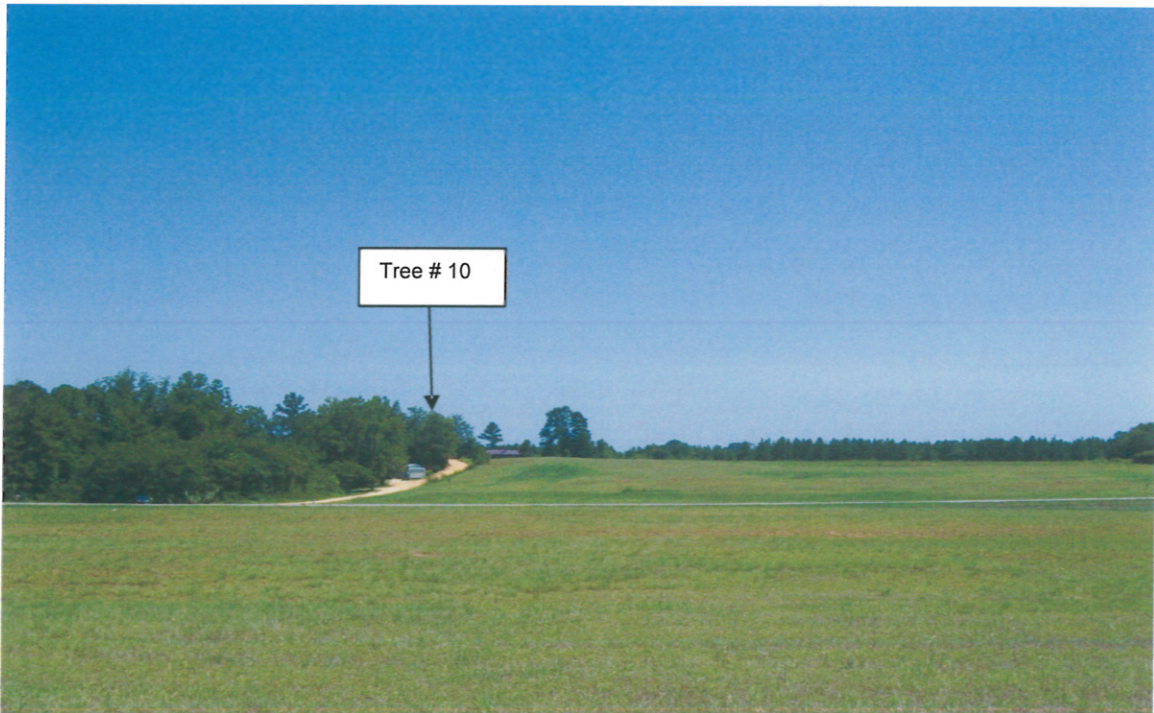
Photo # 4 – Runway 19 Approach

*
10. TREE - 49' ABOVE RUNWAY END
1203' FROM RUNWAY END
200' RIGHT OF RUNWAY CENTERLINE
20:1 OBSTRUCTION CLEARANCE SLOPE

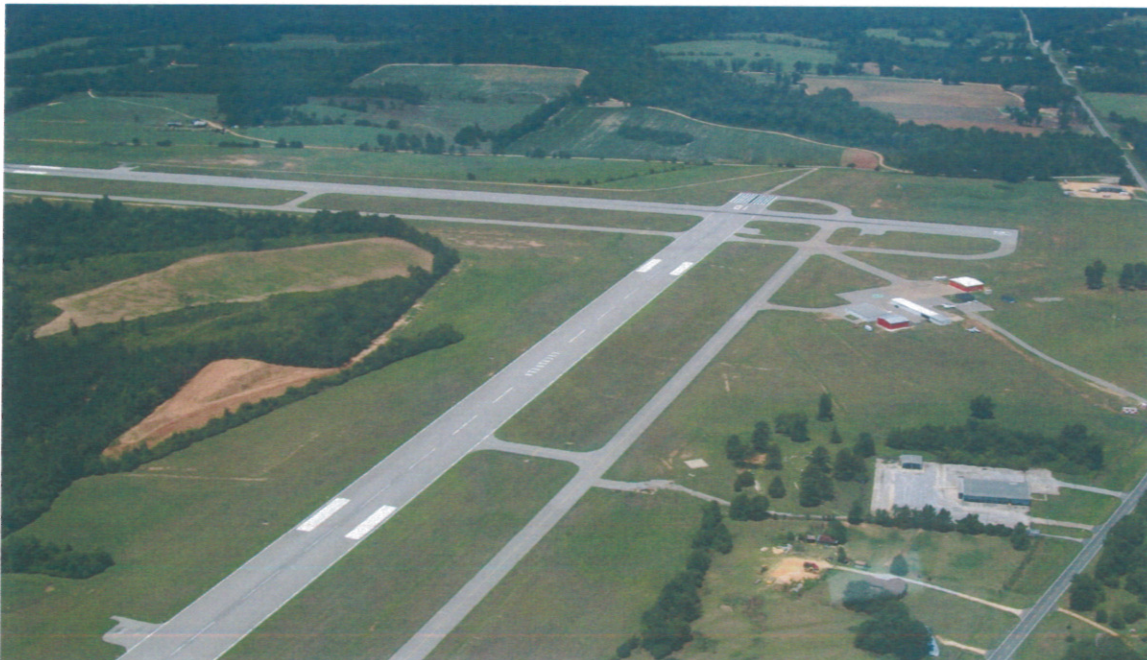
Photo # 5 – Primary Surface

- The primary surface meets state licensing requirements (See Photo # 5).

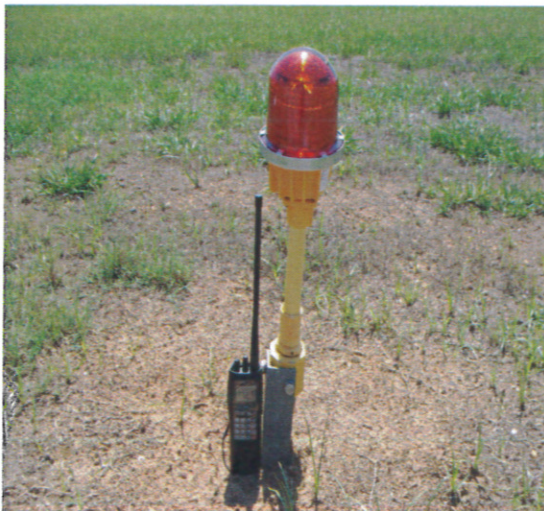
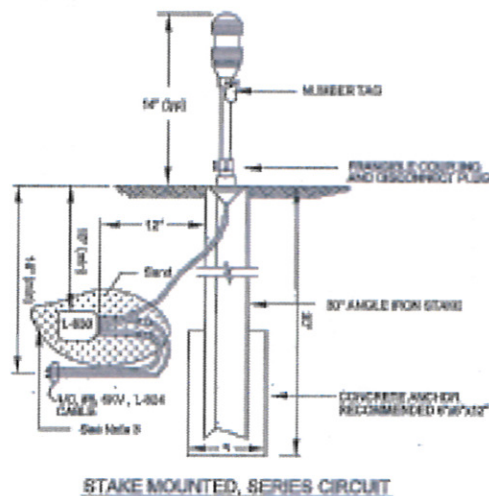
Photo # 6 – Runway 28 Safety Area

- The grading of the runway safety area meets state licensing requirements; however the threshold lights for runway 28 are mounted on angle iron stakes which extend more than 3 inches above the surface (See Photo # 6).

- Angle iron stakes must be buried below surface, as depicted in the illustration in photo # 6.

Also as mentioned in Section 3 above, runway 28's threshold light mounting stakes must be buried flush with runway safety area surface.

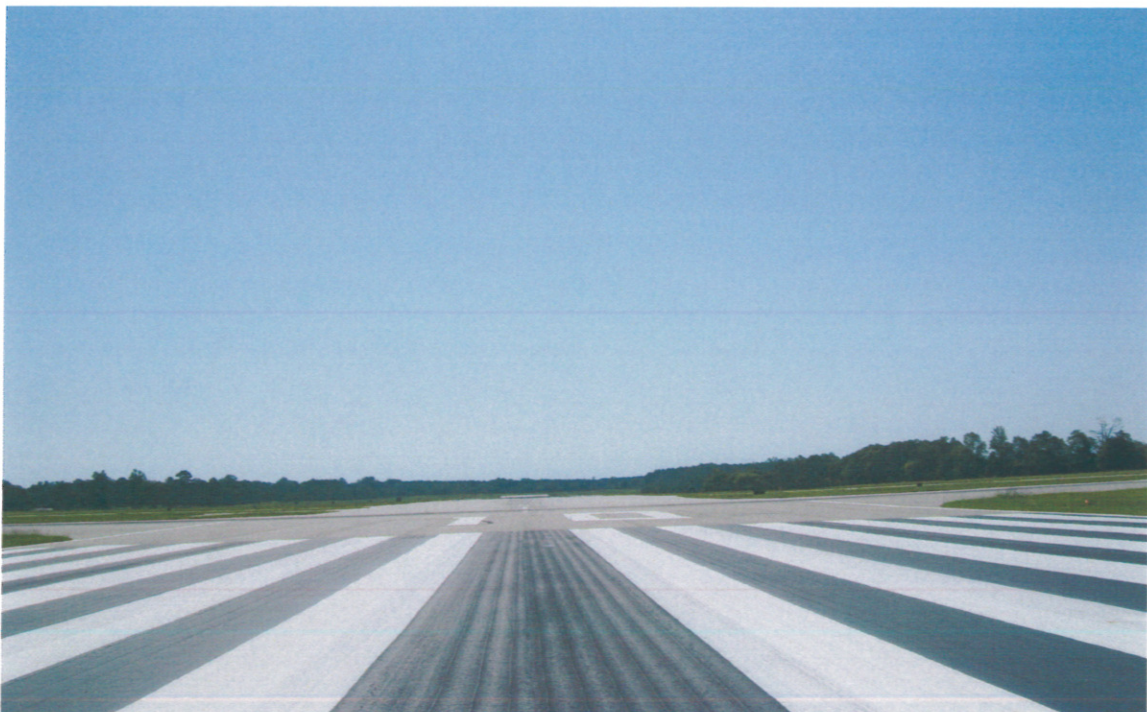
Photo # 7 – NPI Markings Rwy 10

- The airport markings are in good condition (See Photo # 7 and Photo # 8).

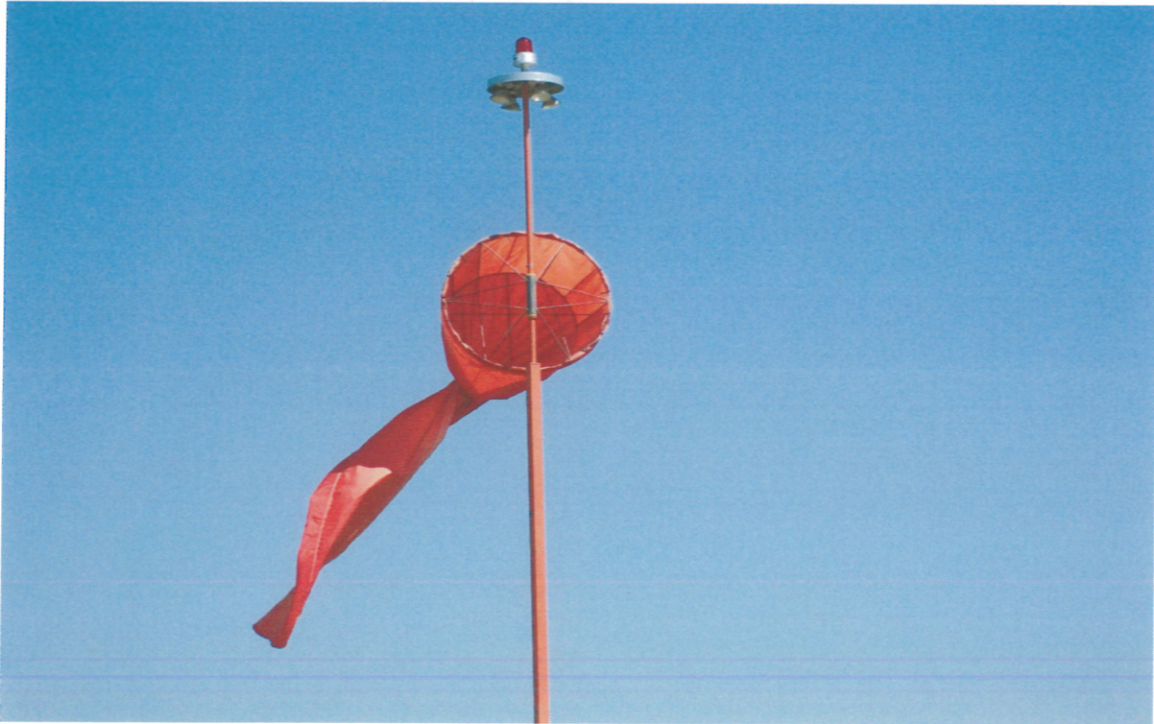
Photo # 9 – Wind Cone

- The wind direction indicator (wind cone) is operational and the fabric is bright and highly visible (See Photo # 9).

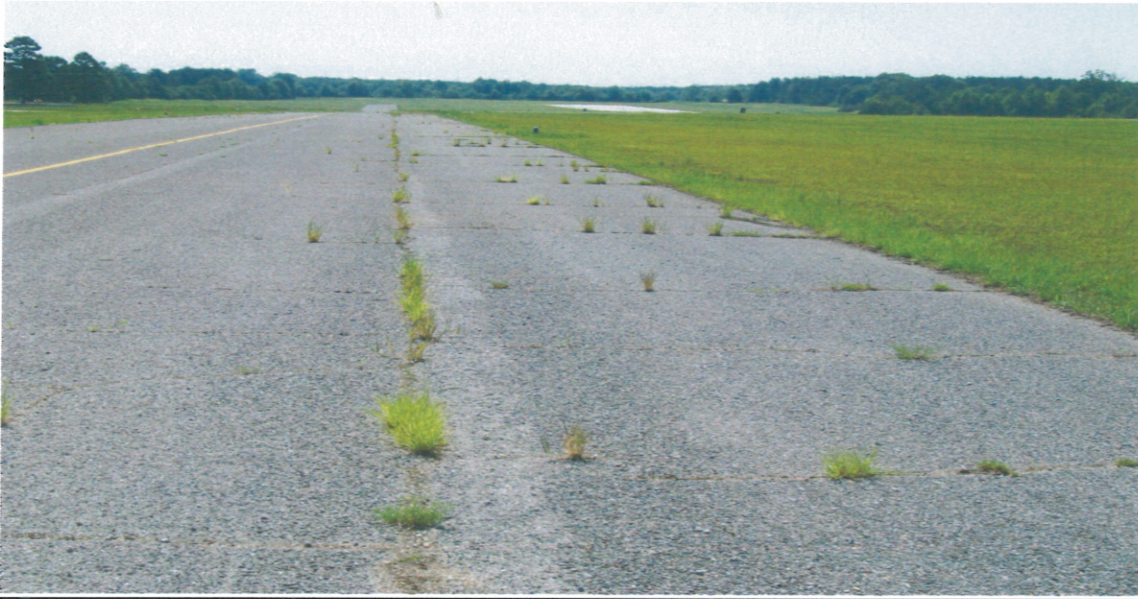
Photo # 10 – Taxiway Surface

- The airport pavement surfaces are in good condition with the exception of runway 10/28's parallel taxiway, which is in poor condition due to extensive raveling, block and alligator cracking with extensive vegetation growing through the cracks (See Photo # 10).

- Vegetation should be eradicated, cracks should be cleaned and sealed and a thin overlay or surface treatment applied.

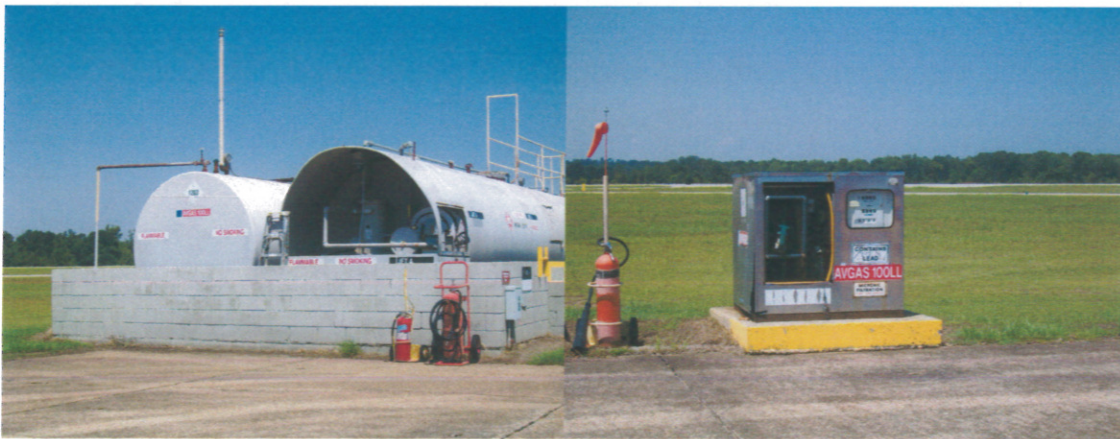
Photo # 11 – Fuel Service Area

- The fueling area meets the requirements established by the Alabama Department of Transportation. However, the State of Alabama Department of Agriculture and Industries may have additional requirements for fueling systems that were not considered during this inspection (See Photo # 11).
